NASA Technical Memorandum 4017

Pultrusion Process Development for Long Space Boom Model

Maywood L. Wilson and Robert Miserentino

JANUARY 1988

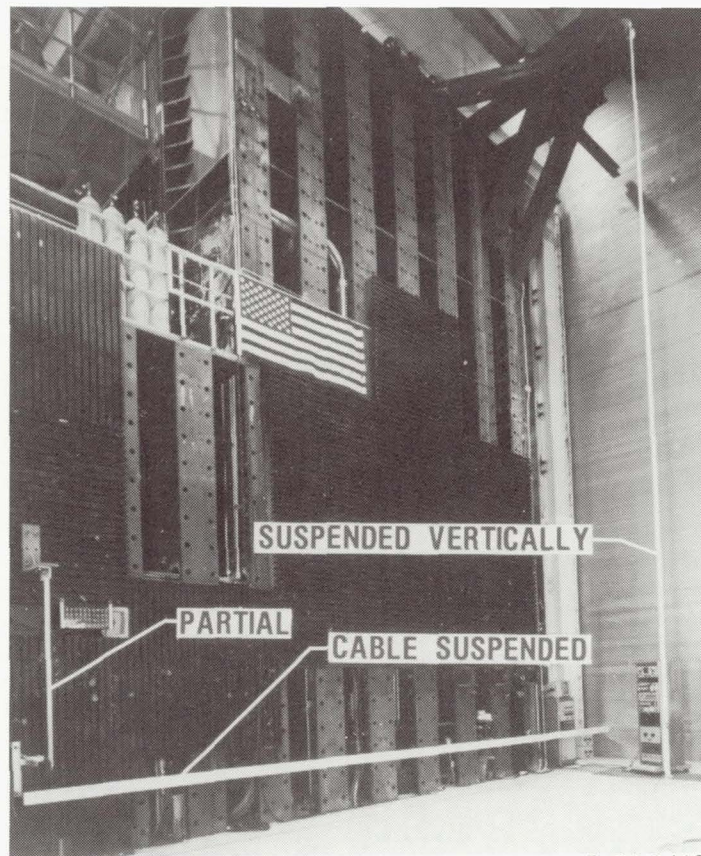
L-83-2412

Figure 1. Dynamic tests of boom models.

Pultrusion is not a new process, it was initiated in the early 1950's. (See ref. 1.) It is, however, still in its infancy in the aerospace industry. The NASA Langley Research Center (LaRC) in Hampton, Virginia, and the U.S. Army Materials and Mechanics Research Center (AMMRC) in Watertown, Massachusetts, are the only government facilities that have in-house pultrusion laboratories with ongoing research and development in pultrusion materials and processes. Experiments are being conducted at LaRC for pultrusion in advanced-composites technology with applications to aeronautical and space structures. In one such program, long flexible beams were needed to establish ground-vibration test methods for very-low-frequency structures. The beams were rectangular in cross section, 0.250 in. in thickness, 4.000 in. in width, and 32.81 ft in length; the beams weighed 25.6 lb each. In figure 1, suspended beams are shown undergoing dynamic tests.

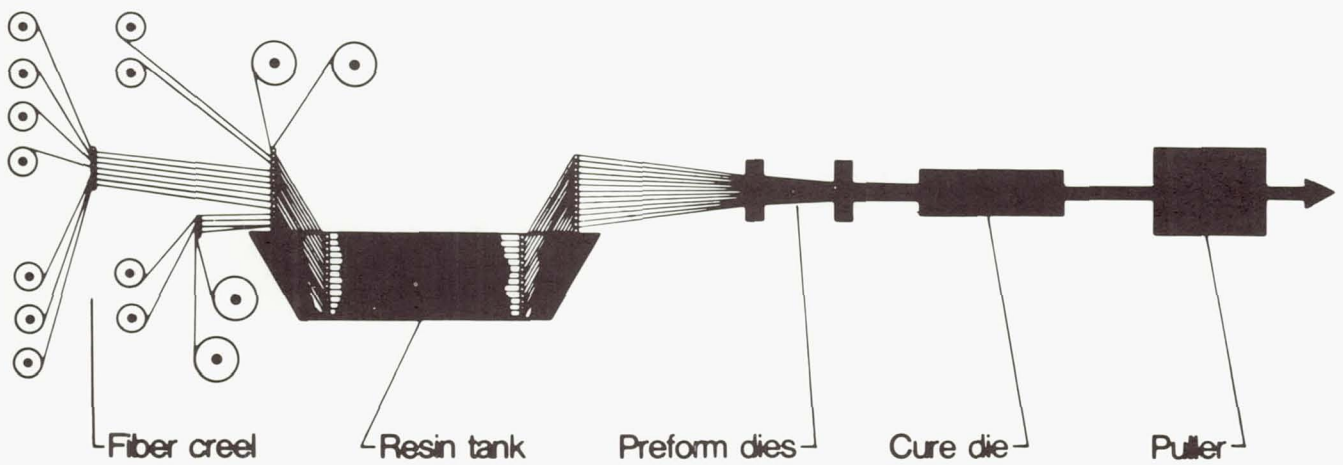
Figure 2. Pultrusion process.

The continuous-reinforcement pultrusion method was used to produce the beams at a rate of 1 ft per minute. Rolls of the reinforcement materials were mounted on a creel and pulled through a resin bath. Each ply was separated by holddown spreader bars as it traveled through the resin system. (See fig. 2.) Approximately 1741 ft of material was pultruded in nine runs for this project. The cure die was machined from 17-4 PH (precipitation-hardened) stainless-steel, heat-treated to Rockwell C-45, and surface-finished to 9×10^{-6} in. root mean square (rms). Electrical strip heaters were used to heat the die, and thermocouples were used to monitor and control die heat zones. (See fig. 3.) The die cross-section dimensions were constant, and its length was 30 in. Die-temperature profiles of runs 22583-5, 82483-9, and 111380 with matrices of resin systems 1, 2, and 3 (table I), respectively, are shown in figure 4. The die station with the start-up winch attached is shown in figure 5.

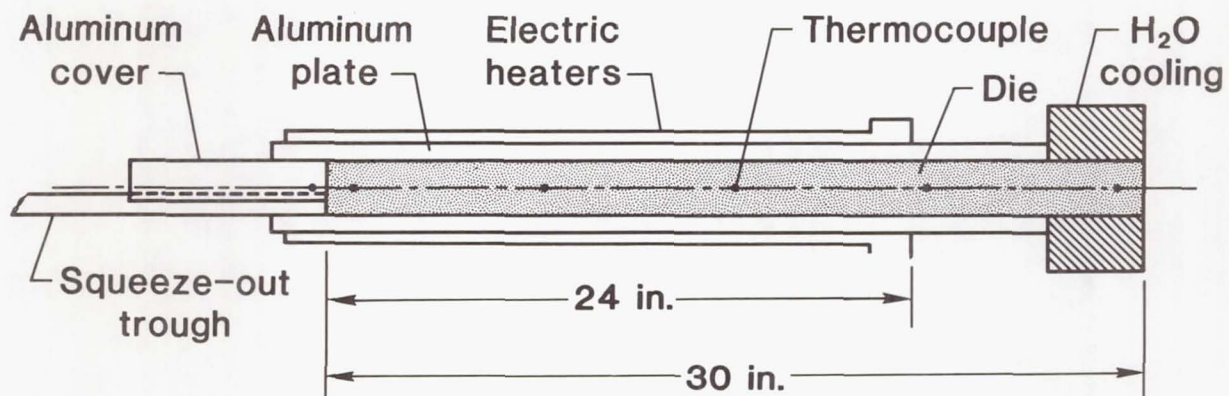
Figure 3. Profile view of pultrusion die.

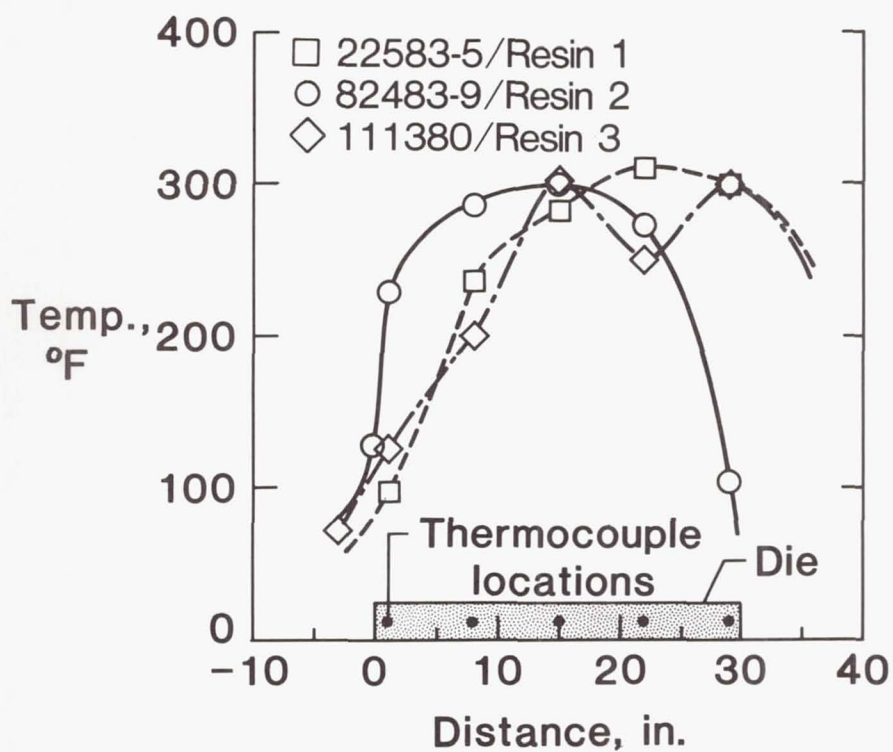
Figure 4. Die-temperature profiles of pultrusion processes.

Processing problems encountered were surface roughness, scaling, sloughing, cracking, voids, delaminations, and tapered edges. Sections of three pultrusion runs depicting surface and delamination problems (top specimen), tapered edges (center), and the developed process (bottom) are shown in figure 8. The problems were divided into the following three groups for analysis and correction: (1) resin system, (2) reinforcement material, and (3) cure cycle. Resin-related problems were surface roughness, scaling, sloughing, cracking, and delaminations. These problems were eliminated, with the exception of some scaling, by changing to resin system 2. Thermal analysis using a Dupont 1090 differential scanning calorimeter (fig. 9) shows that resin system 1 has a single catalyst with one exothermic peak and a short reaction range, whereas system 2 has a double catalyst, two exothermic peaks, and a broader reaction range. The latter system is indicative of a less violent, lower rate of reaction, which allows the resin to cure more uniformly from the center outward to the surfaces. This uniform curing process accounts for some of the process improvements made by resin system 2. The probable cause of excessive voids and delaminations in the pultrusions using resin system 1 was free moisture produced by the alumina trihydrate when it was heated to processing temperatures. Some improvements in the surface finish were achieved by adding Nexus² polyester surfacing veil style 131-10. Finally, after adjusting the die exit temperature below 240°F by installing a water-cooling unit (fig. 3) over the last 4 in. of the die, scaling was completely eliminated and an excellent surface finish was produced. A die-temperature profile of the developed process (82483-9/Resin 2) is shown in figure 4.

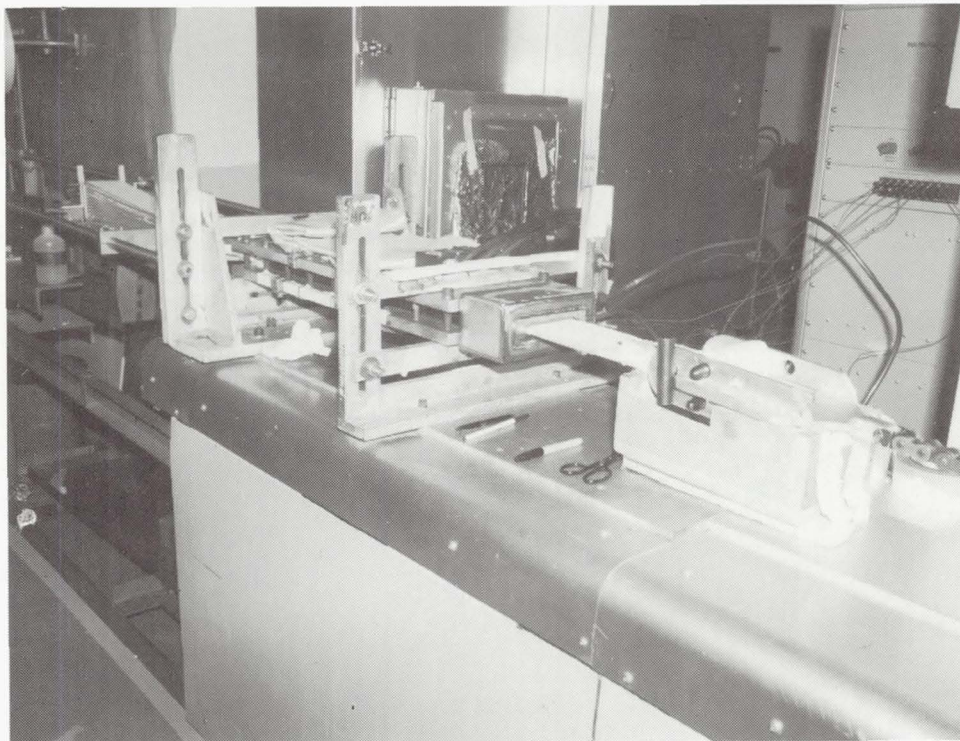
L-84-6814

Figure 5. Die station showing start-up mechanism.

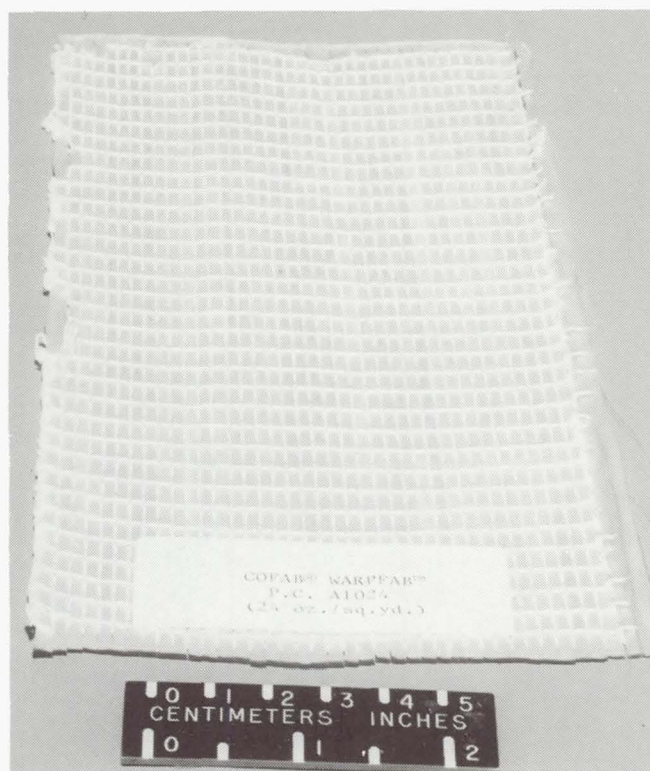
L-84-7743

Figure 6. Unidirectional material, knit-locked fiberglass.

material consists of fiberglass (electrical grade, E fabric glass) rovings locked together by a knitted polyester yarn to form a stable cloth-like fabric. (See figs. 6 and 7.) This material is available in orientations of $[0^\circ]$, $[90^\circ]$, $[0^\circ/90^\circ]$, and $[\pm 45^\circ]$ directions. Seven pultrusion runs were made with fiber orientation combinations of $[0^\circ]$ and $[0^\circ/90^\circ]$ plies, and two runs were made with all $[0^\circ/90^\circ]$ orientations.

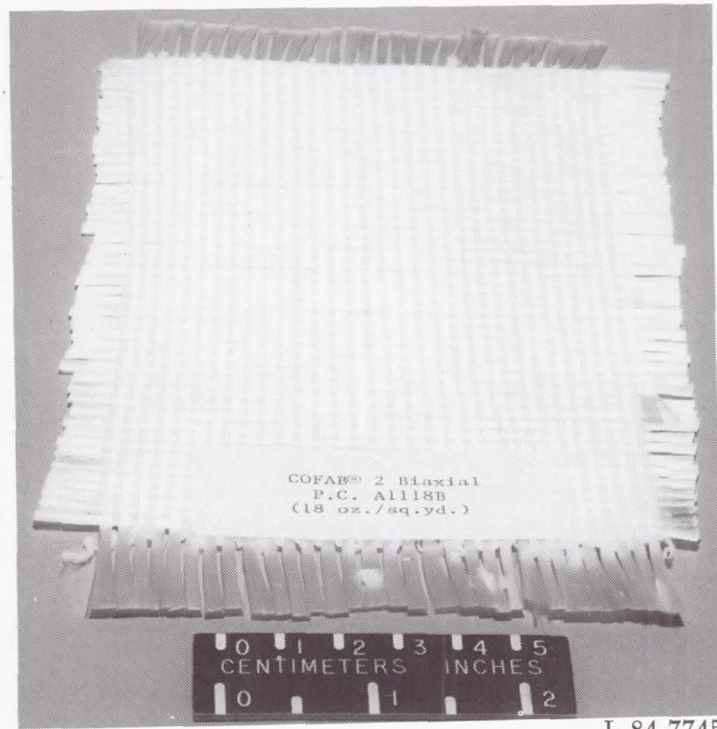
L-84-7745

Figure 7. Biaxial material, knit-locked fiberglass.

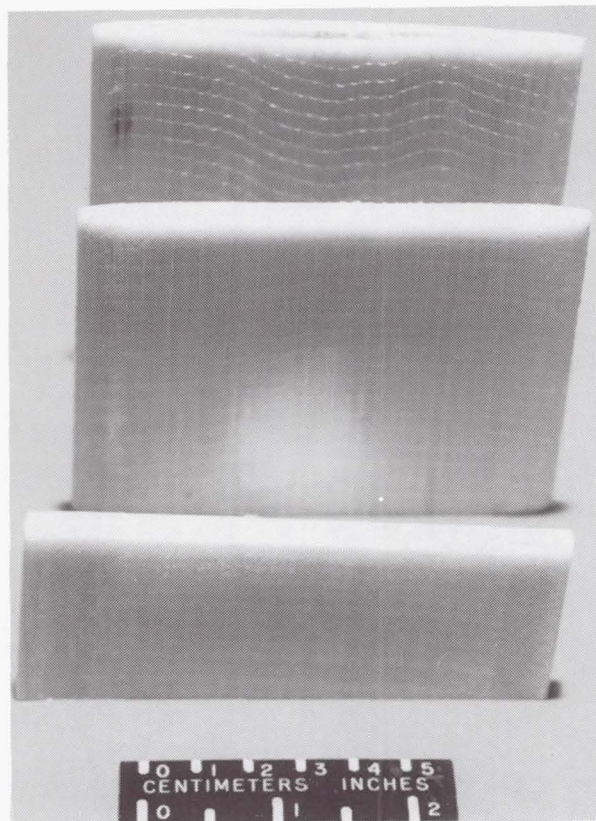
L-84-7741

Figure 8. Sectioned pultrusions showing defects.

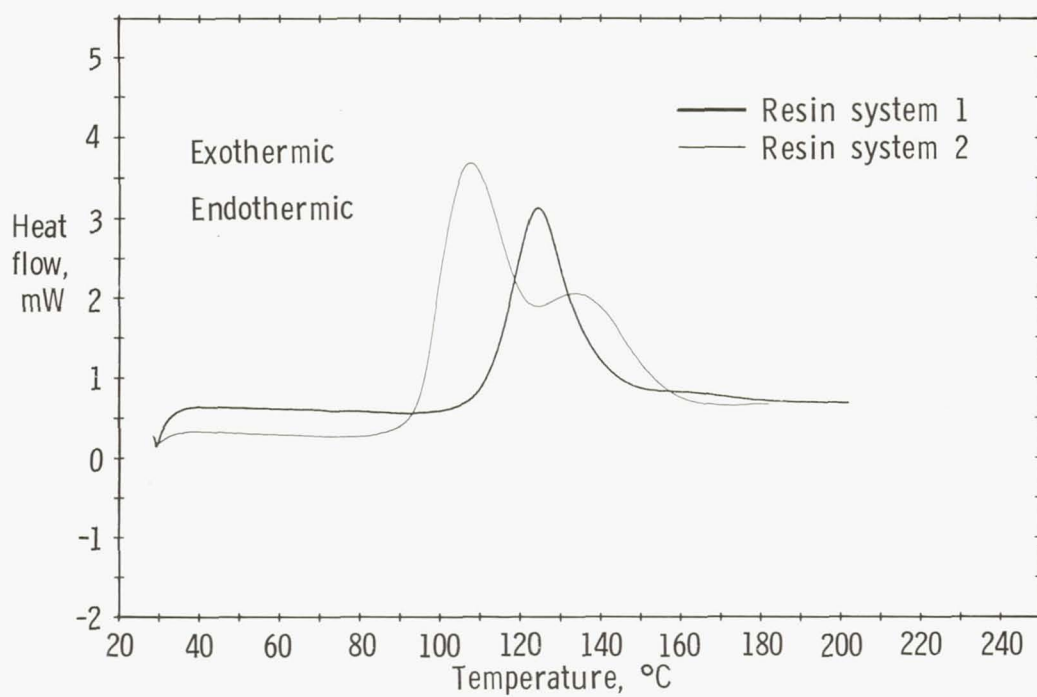
Figure 9. Differential scanning calorimeter (DSC) thermogram of polyester resins.

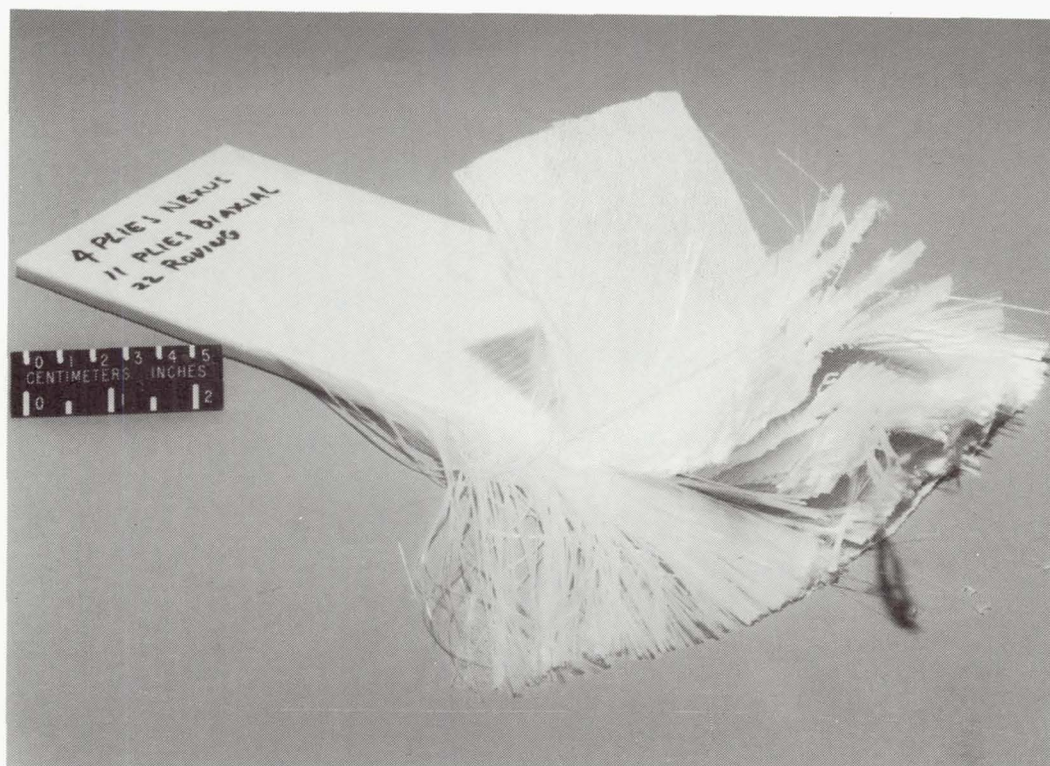
L-84-7742

Figure 10. Start-up end of pultrusion run.

by adding $[0^\circ]$ roving. The final reinforcement lay-up consisted of two plies of Nexus veil; 11 plies of $[0^\circ/90^\circ]$ biaxial COFAB, 18 oz/yd²; two rovings 30 K (see ref. 1), 112.5 yd/lb yield for each $[0^\circ/90^\circ]$ biaxial ply (one such roving applied to each outside edge); and two plies of Nexus veil, style 131-10 (fig. 10).

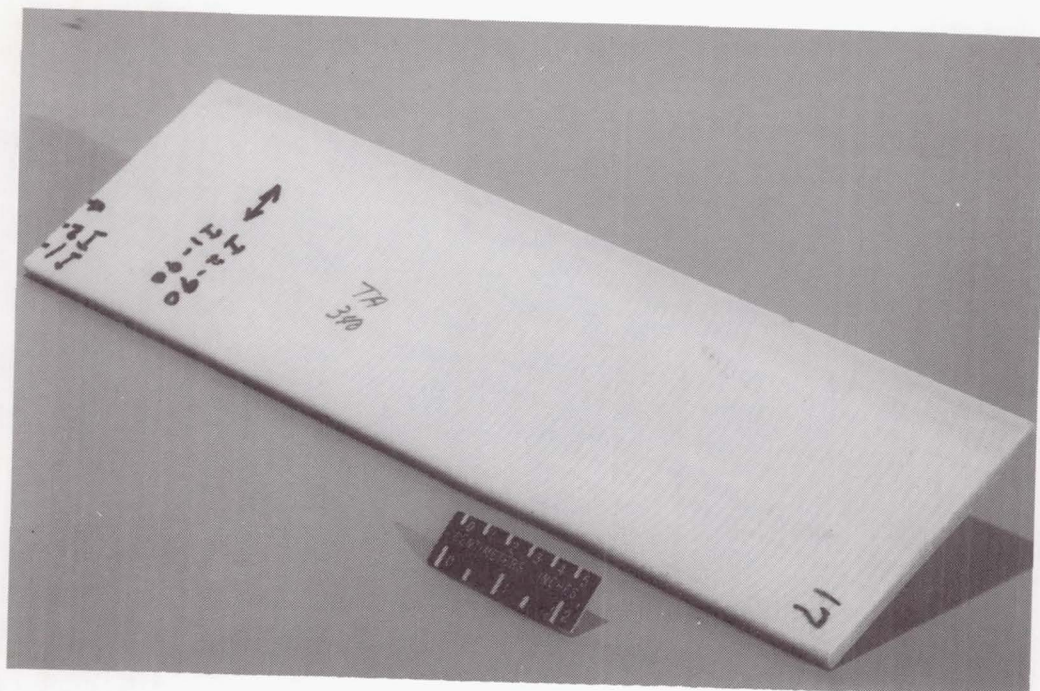
L-84-7746

Figure 11. Section of pultrusion run 82483-9.

Identical tests were conducted on samples sectioned from pultrusion runs 82483-9, the final developed beam model (fig. 11); 22583-5, a beam-model run made during the development stage; 111380, which contains all unidirectional roving with cross-sectional dimensions of 0.125 in. thick by 1.0 in. wide; and a commercially produced 6-in. H-beam. Physical and mechanical tests results are listed in table III. Fiber volume and weight percent determinations were made by gravimetric analysis. Tensile, flexural, and short-beam shear tests were based on American Society for Testing and Materials (ASTM) Standards D638, D790, and D2344, respectively. These tests were conducted on an Instron testing machine³ Ultrasonic C-scan and Scanning Electron Microscope (SEM) evaluations supported physical and mechanical test results. C-scan test results (figs. 12 to 16) show the following order of quality: (1) 111380, (2) 82483-9, (3) 6-in. H-beam web, (4) 6-in. H-beam flange, and (5) 22583-5. In the photographs, black indicates good quality and white indicates poor quality. The unidirectional roving pultrusion (fig. 12, 1-in.-wide strips with white tabs) appears to transmit the highest volume of sound (black), which is indicative of the lowest void content, better fiber wetting, a higher degree of resin-fiber interface bonding, and an absence of delaminations. Scanning Electron Microscope photographs (figs. 17 to 20) show that 111380 (fig. 17) has the best fiber wetting, followed by 82483-9 (fig. 18), 22583-5 (fig. 19(a)), and the H-beam (fig. 20(a)). Internal microcracks and excessive voids in the polished cross section of 22583-5 are shown in figure 19(b). Internal microcracks in the polished cross section of the H-beam are shown in figure 20(b).

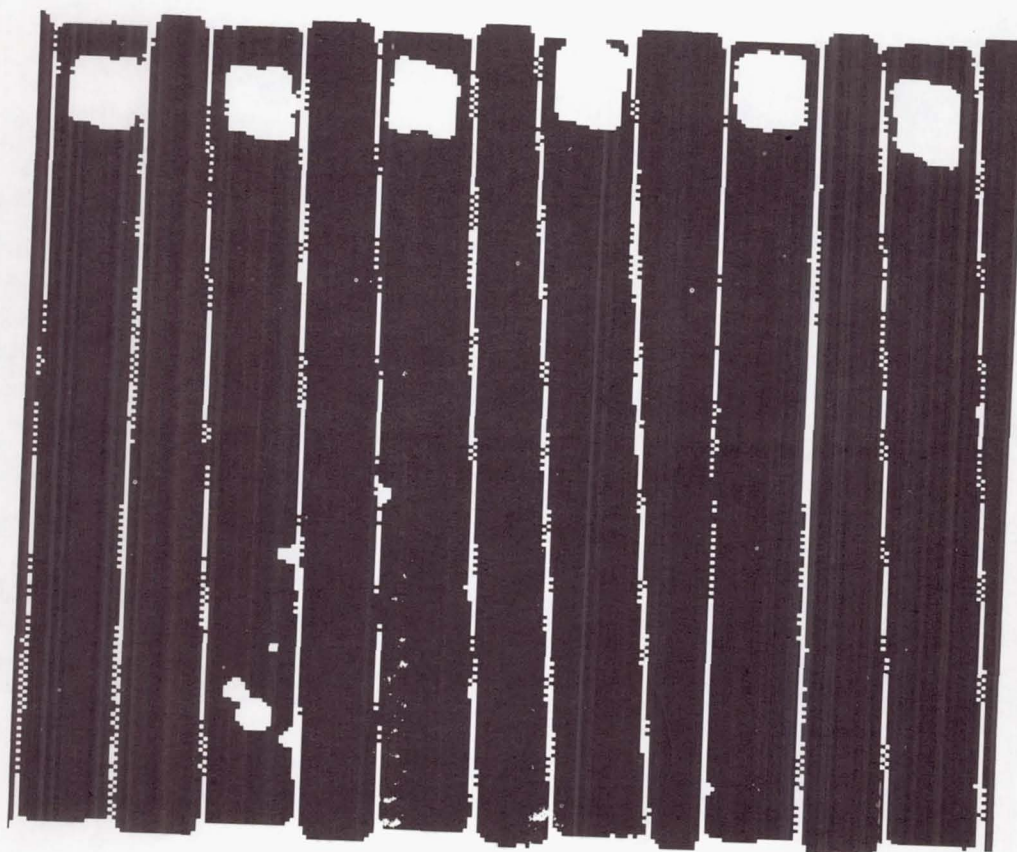
L-87-660

Figure 12. C-scan of pultrusion run 111380.

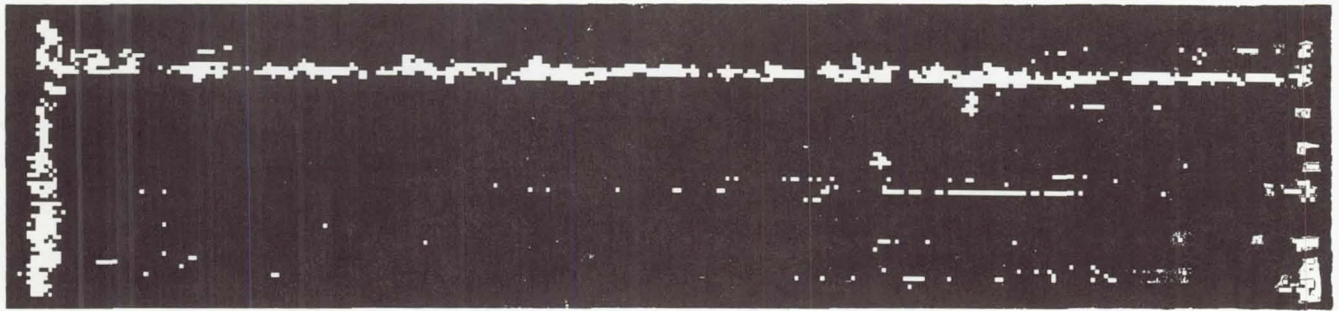
L-87-661

Figure 13. C-scan of pultrusion run 82483-9.

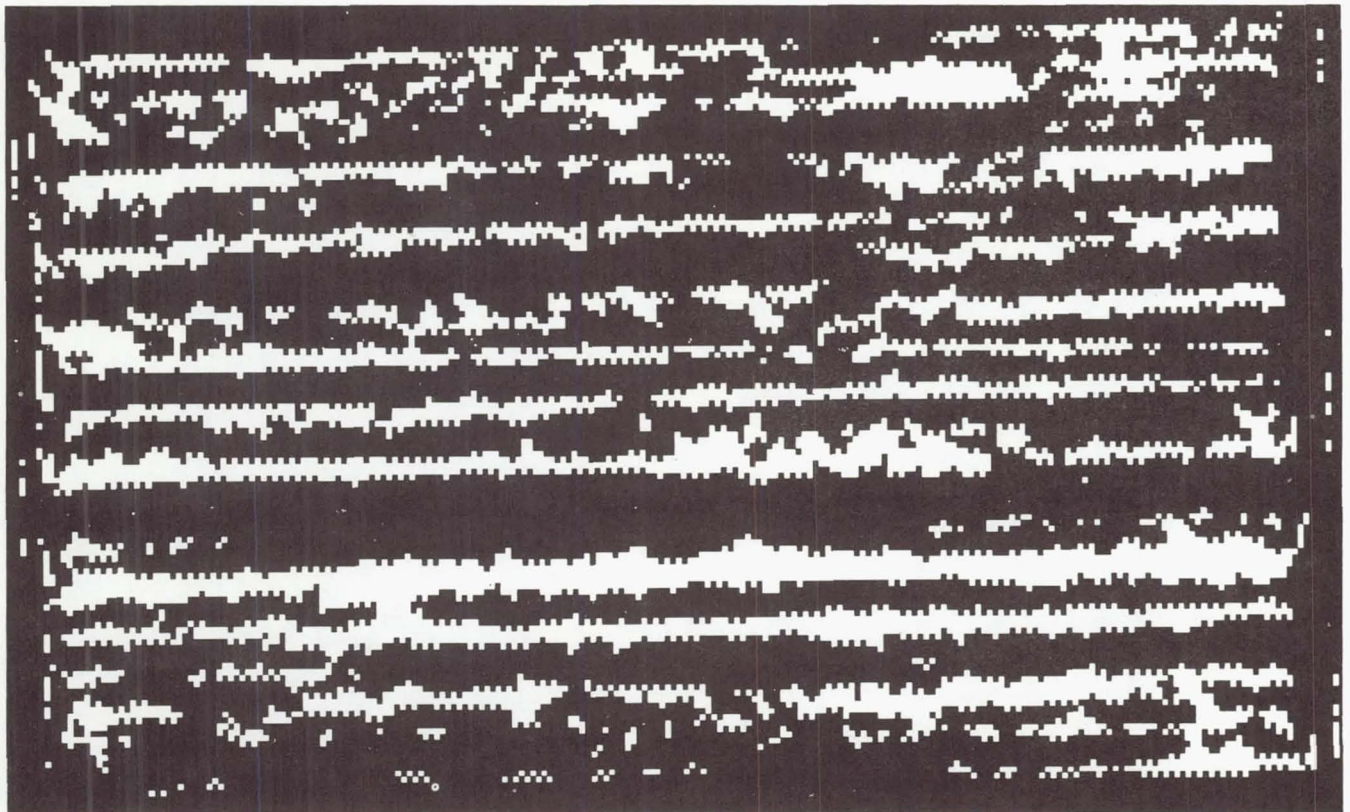
L-87-662

Figure 14. C-scan of sample from pultruded H-beam web.

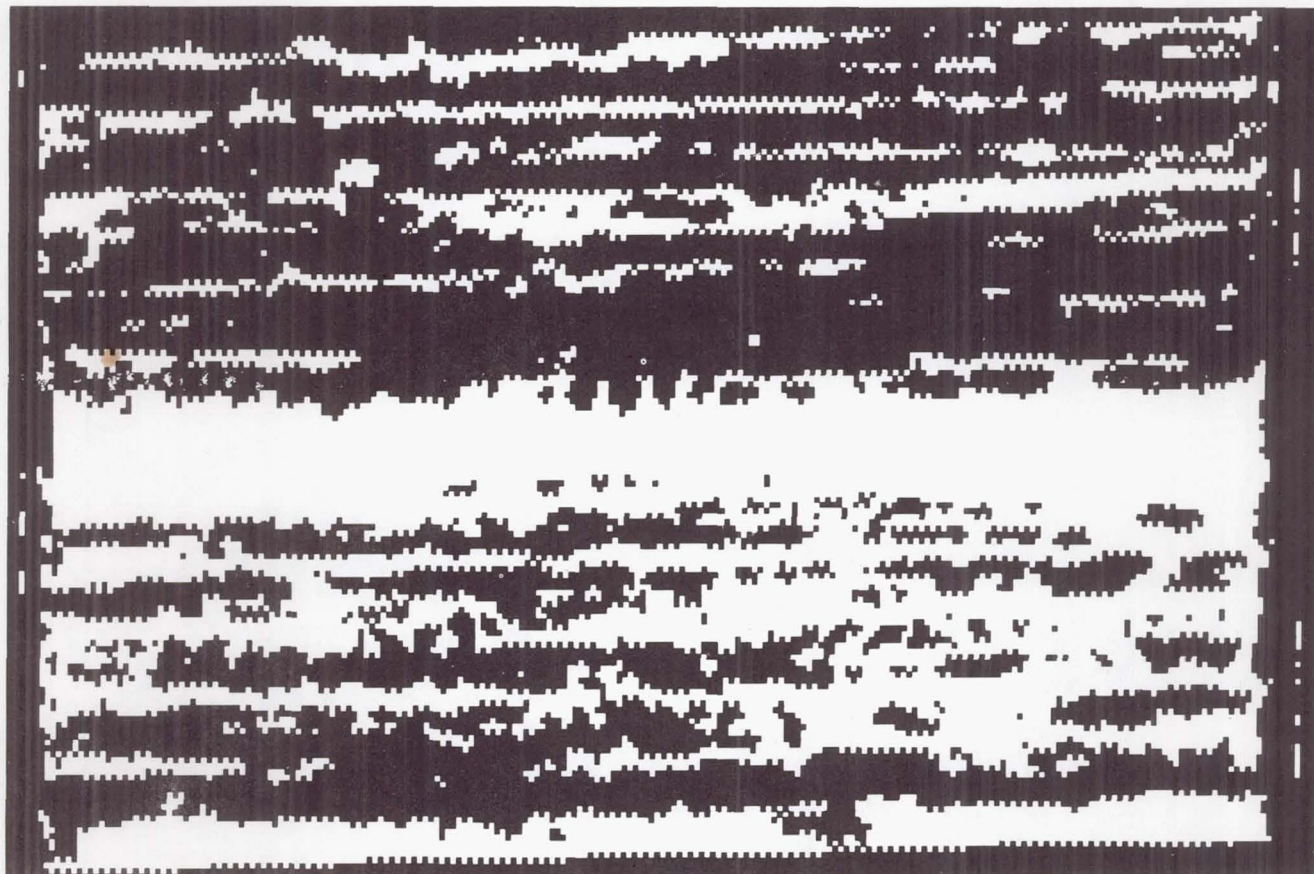
L-87-663

Figure 15. C-scan of sample from pultruded H-beam flange.

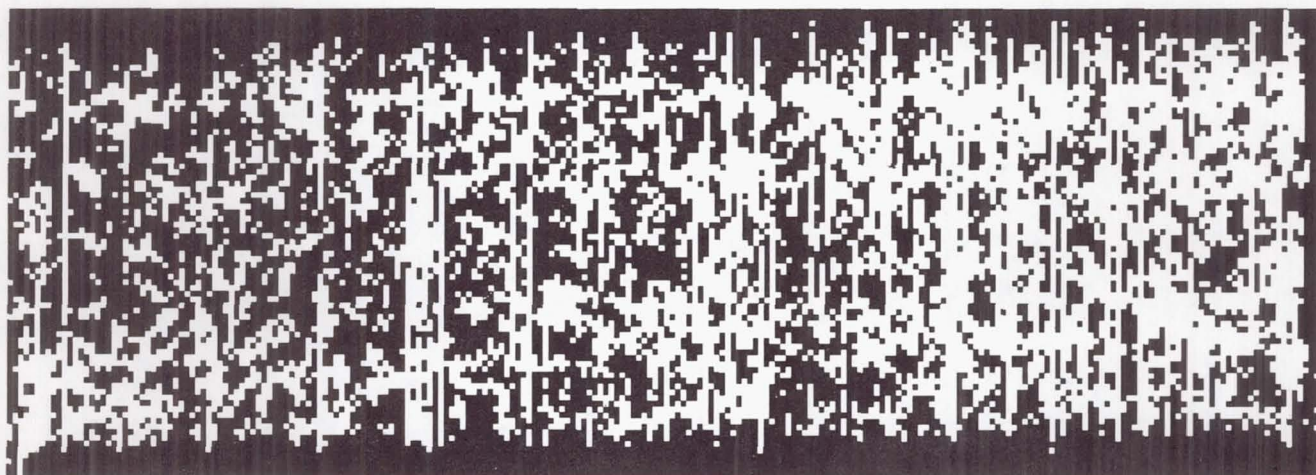
L-87-664

Figure 16. C-scan of pultrusion run 22583-5.

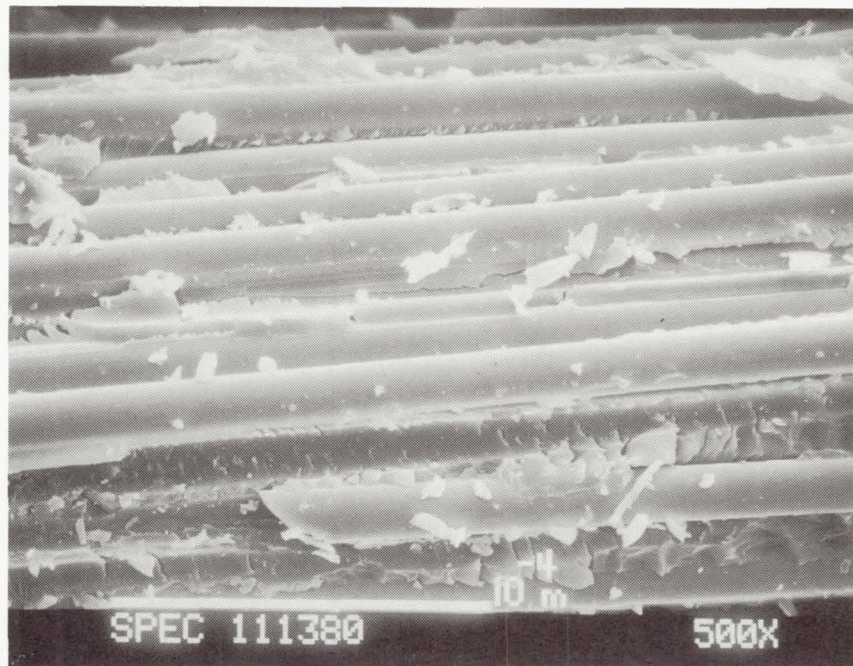
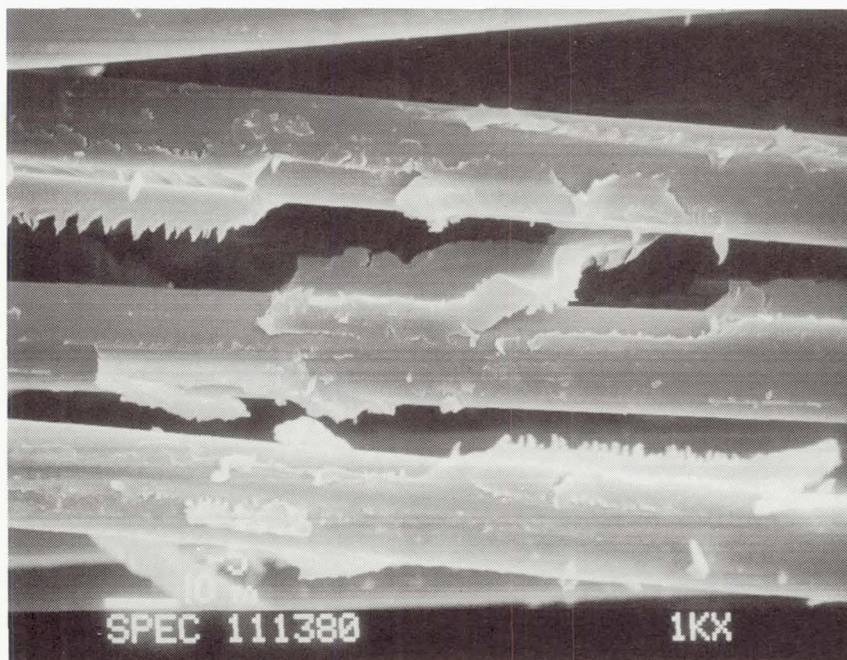
L-87-665

Figure 17. Photomicrographs of fracture-face samples from pultrusion run 111380.

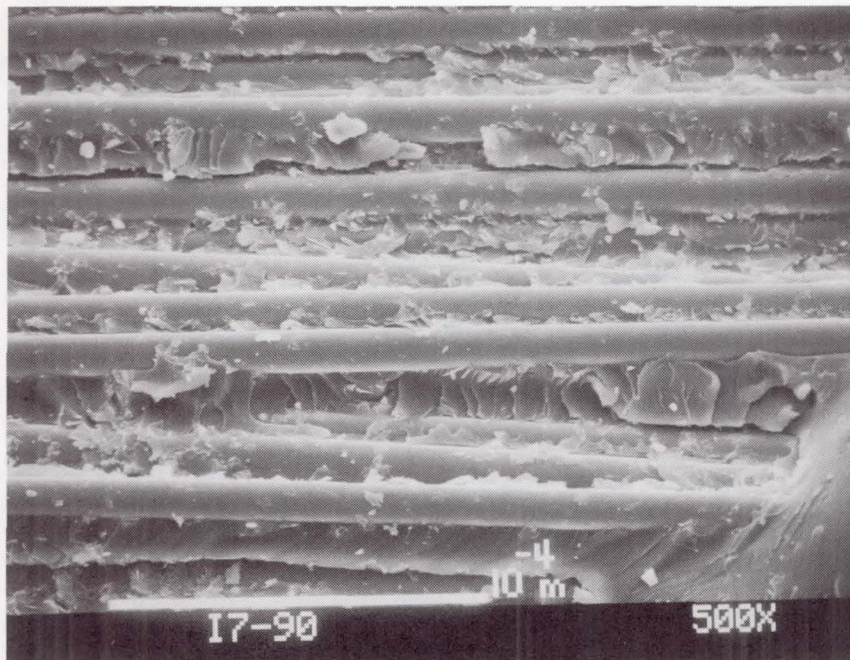
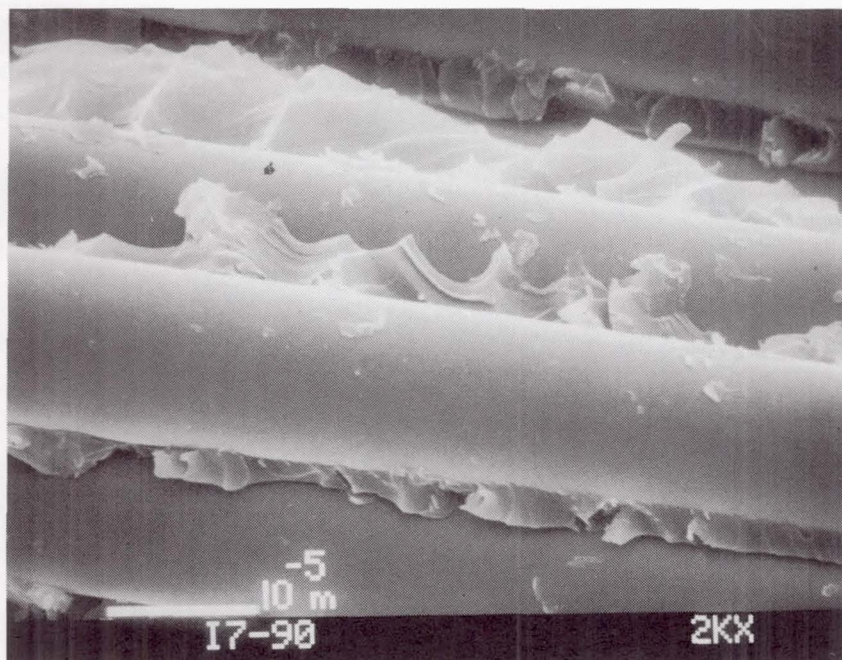
L-87-666

Figure 18. Photomicrographs of fracture-face samples from pultrusion run 82483-9.

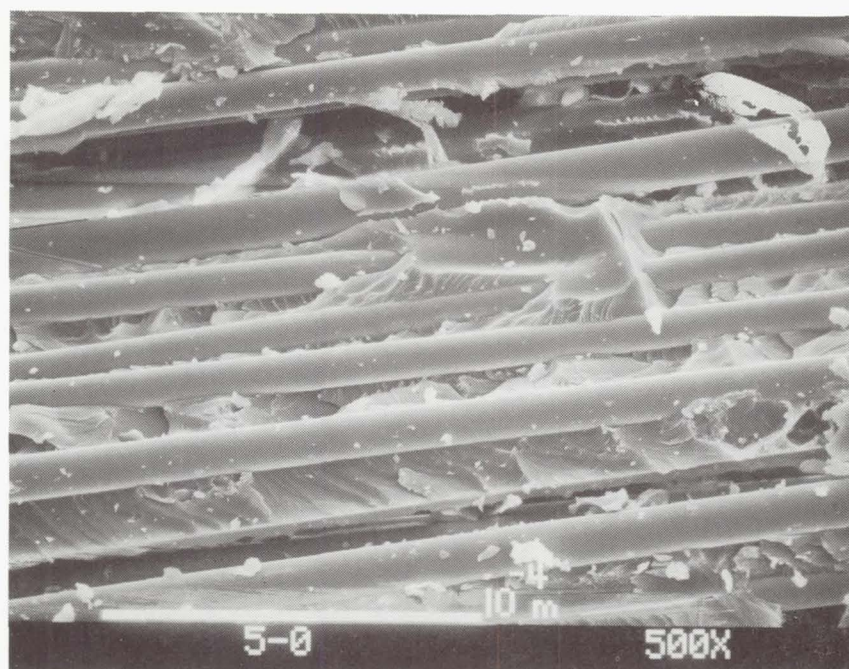
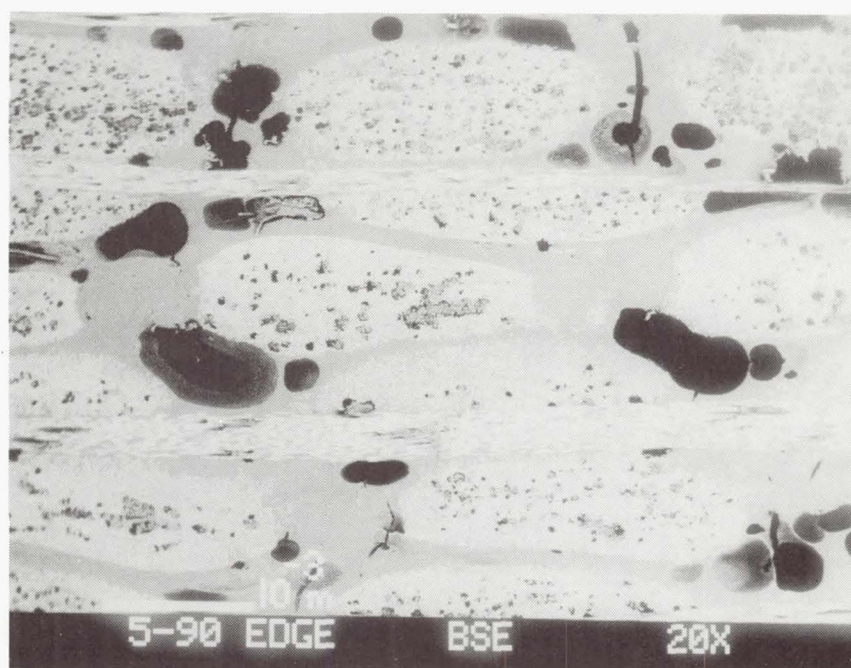
L-87-667

(a) Fracture face.

(b) Cross section.

Figure 19. Photomicrographs of samples from pultrusion run 22583-5.

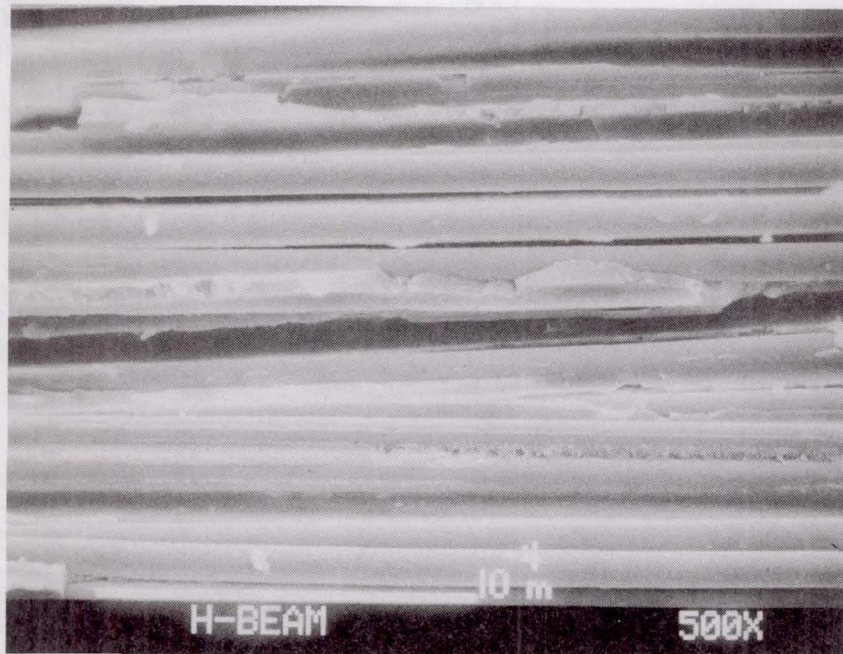
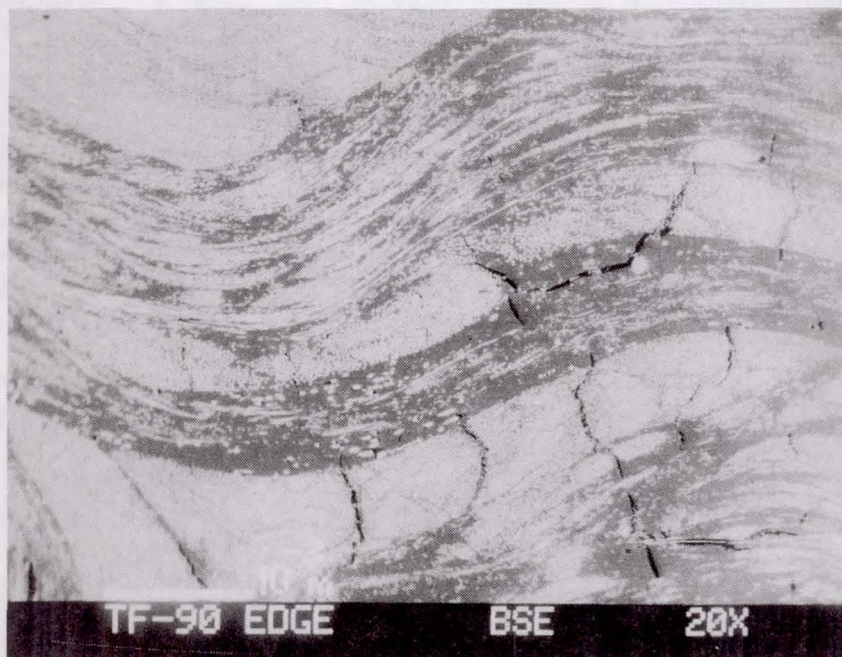
L-87-668

(a) Fracture face.

(b) Cross section.

Figure 20. Photomicrographs of samples from H-beam pultrusion.
